# Manhole Inspection Summary

Manhole # S53G\_\_001MH

Record Plat: **53G** Node: **001** Status: **Found**

**Location** Address: **3301 S Clinton St**

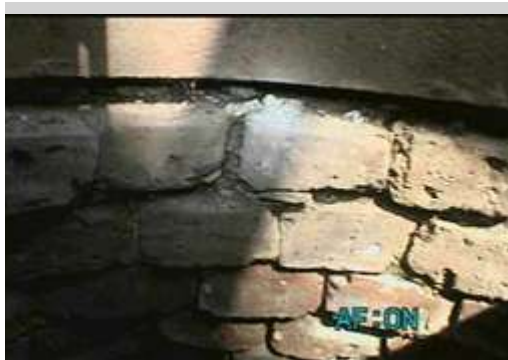
Defect 2

Condition: ☐ Sound ☐ Cracked ☐ Root Intrusion ☒ **Loose Brick** ☐ Deteriorated

loose brick in frame adjustment

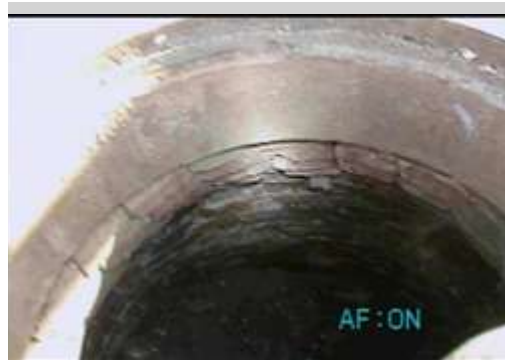
Defect 1

**Steps** Count: **2** Missing: **0** ☒ **Corroded**

corroded missing stairs

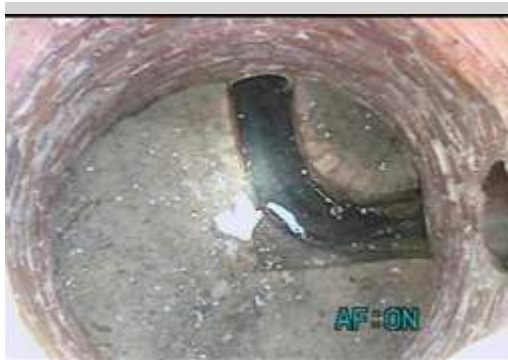
Defect 3

Condition: ☐ Sound ☐ Cracked ☐ Root Intrusion ☐ Deteriorated ☐ Leaks ☒ **Debris**

bench debris
